PRELIMINARY OBSERVATIONS IN THE AFTERMATH OF THE SEPTEMBER 19, 2017 PUEBLA–MORELOS EARTHQUAKE

Abel Díaz, PE SE (M.EERI, 2011), Patrick Murren, PE and Samantha Walker, PE

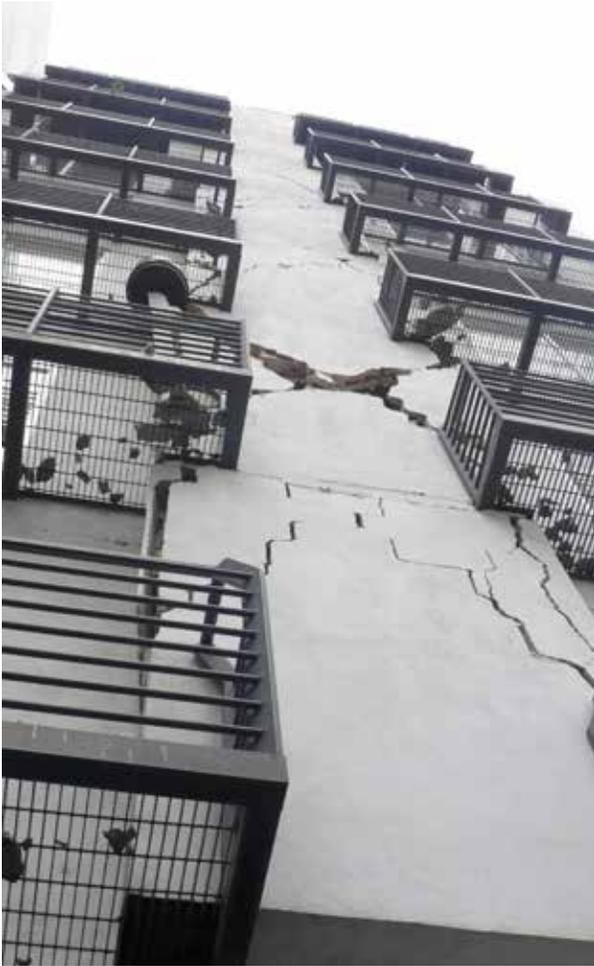
Fig. 8: Deformation-induced diagonal shear cracking of a masonry panel detailed integral with the lateral frame system (SOM).

Failures of confined masonry walls were also common. This system, frequently used in Mexico City, is composed of reinforced column and beam frame members and a lightly or even unreinforced masonry wall. The reinforced end members provide confinement for the masonry infill and enhance the ability of the wall to act as a shear load-bearing panel. Failure in the masonry panel can occur due to shearing and out-of-plane collapse (in occasions caused by pounding), both of which were observed in the field either in isolation or in combination. Panels that experienced diagonal shear cracking and failure in the mortar posed additional out-of-plane falling hazards in subsequent aftershocks. In some cases, diagonal cracking was observed to have extended into the vertical concrete elements.

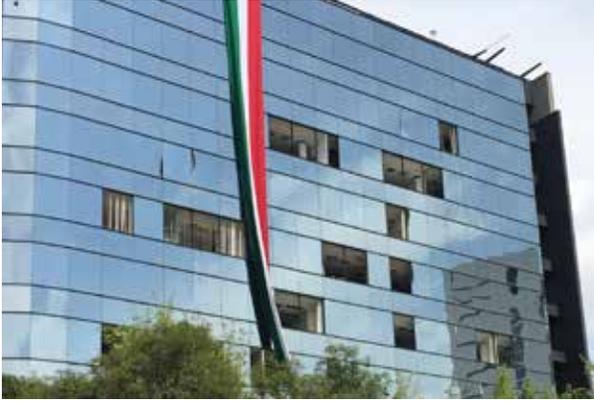
Nonstructural damage modes such as cracked glass, spalling of plaster and brick facades, and collapse of parapet walls and canopies were among the most frequently observed types of damage. Usually, it appeared that damaged nonstructural elements and facades were either not properly designed to withstand deformation-induced demands or not properly detailed to allow

Fig. 9: Damaged glass cladding on an office building along Paseo de la Reforma (SOM).

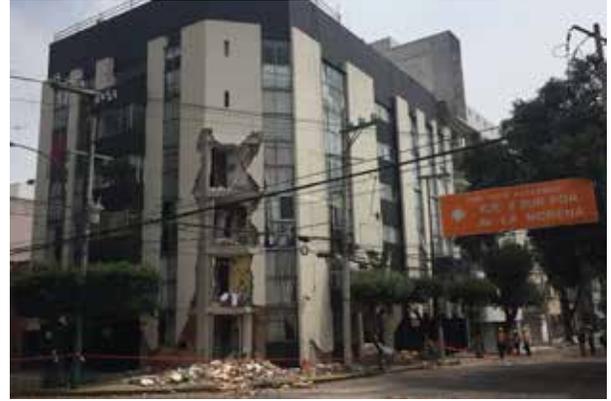
Fig. 10: Collapse of confined masonry panels (SOM).

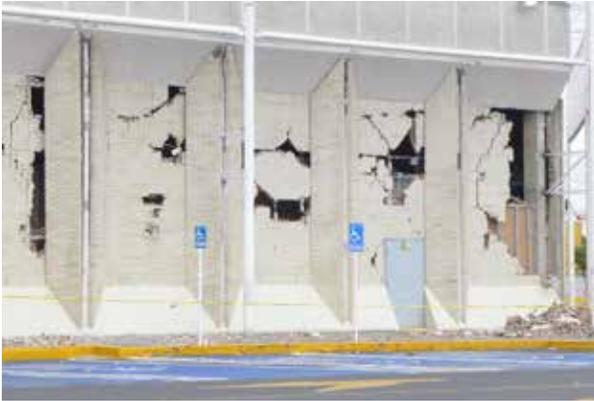
for slip and provide release from such demands. Numerous cases of cracked or shattered glass, spalled plaster, and cracked or collapsed masonry facades were documented, including in more modern buildings. Additionally, in multiple cases, it was observed that portions of facades had cracked or collapsed due to pounding impact from neighboring structures.

Fig. 11: Facade damage due to building pounding (SOM).

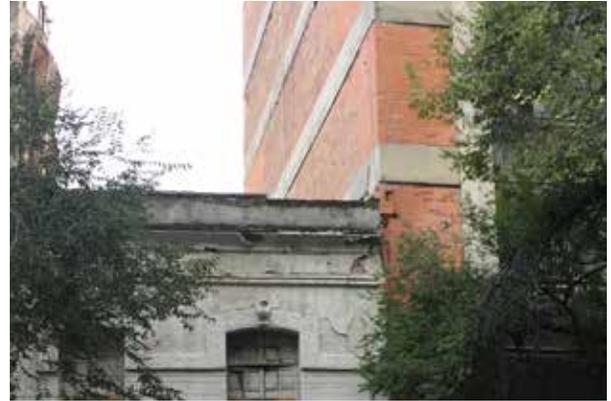
A number of buildings were observed to have residual drifts after the earthquake, relatively easy to identify without the use of any surveying equipment given the minimal separation between structures. There were also instances where lack of plumbness was observed, most likely due to differential settlement related to the regional subsidence in the Mexico City clays. Residual drift issues could sometimes be distinguished from settlement issues either by partial loss or damage of architectural flashing that had previously covered building separations, or by impact damage due to pounding.

Fig. 12: Example of building with post-earthquake residual drift (SOM).

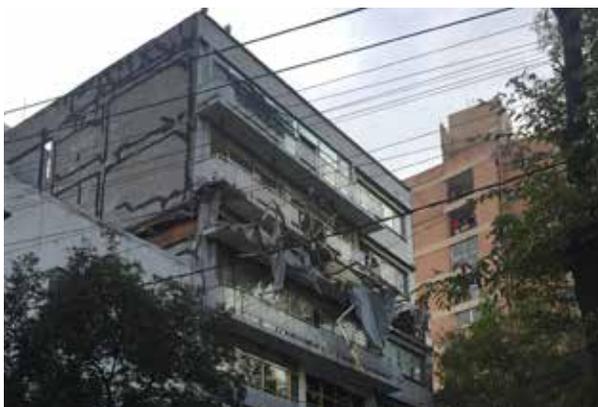
Soft story mechanisms were occasionally observed. A pancaking collapse of a mid-rise structure was observed in the Hipódromo neighborhood, close to Parque México. At one end of the structure, the top two stories had completely sheared off from the vertical support. At the other end, the top two stories were still resting on a column where concrete had crushed, the longitudinal bars had buckled, and confining tie reinforcement was not visible from the street. It was observed that the failure occurred at the level where the roof of the adjacent structure was located. Given the relative lack of damage elsewhere in the structure, it is possible that the neighboring structures, without adequate seismic separation, provided an unintended inflection point at the collapsed story, triggering a shear failure in the vertical elements where the soft story collapse occurred.

Fig. 14: Soft story partial collapse of a mid-rise structure observed in the Hipódromo neighborhood (SOM).

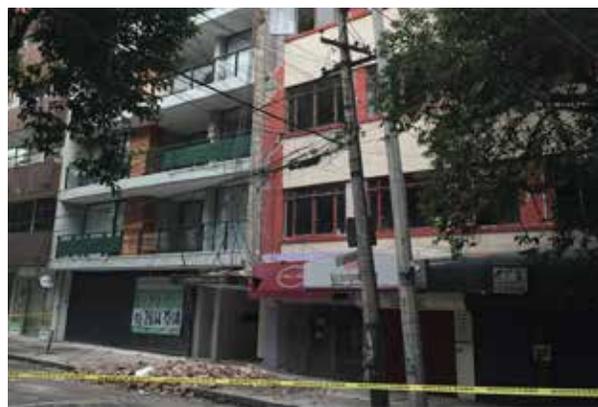
Structures at block corners that appeared to be affected by torsional irregularities were also common among the documented collapses, as observed for a building located adjacent to the Parque México. Two orthogonal sides of the four-sided structure were entirely composed of a form of masonry wall; the other two sides had frame configurations and were located at the block corner. When observed, the building appeared to have twisted due to this irregularity. The building was both leaning on the neighboring structure with pounding damage visible, and leaning away from the street, as evidenced by comparing the profile of the structure with its apparently plumb neighbor. Damaged columns, including shear-related failures at the corner columns subjected to pounding impact from neighboring structures, were observed.

Fig. 15: Corner building near Parque México with apparent torsional irregularity leaning on its neighbor on the verge of collapse (SOM).

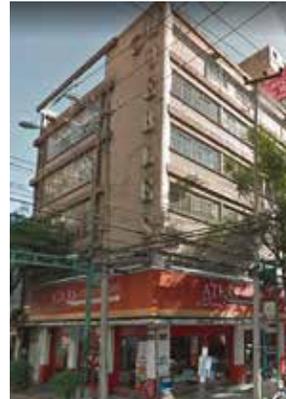
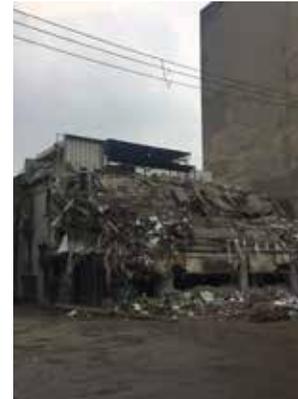
A collapsed building was observed in the Roma Sur neighborhood, roughly a block away from Avenida de los Insurgentes, a main traffic artery through the area. When observed, neither the mode that triggered collapse nor the original size of the building was evident. A subsequent review of a Google Street View image of the building prior to collapse revealed that the structure was much taller than expected and that a wall facing the street appeared to be discontinuous. However, it could not be conclusively determined whether the wall was structural. Further, both in-field observations and other pre-collapse images suggested that the building had a structural system with reinforced concrete columns. Other reconnaissance teams documented common occurrences of failures of reinforced concrete column and flat slab structures (Galvis, et al.), where collapse may initiate through a punching shear failure in the

slab to column connection. Though also unable to be confirmed in this case, a punching shear failure in a flat slab may have precipitated the collapse.

Fig. 16–17: Collapsed building in the Roma Sur neighborhood, before and after (Google Street View and SOM).

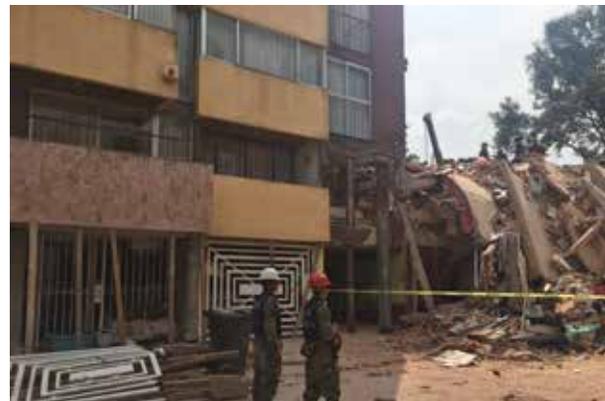
Two neighboring buildings—one collapsed and one severely damaged—were observed in the Valle Centro neighborhood. Significant damage in the corner vertical support of the building still standing was observed. When observed, the structure was supported by temporary steel shoring posts in an attempt to prevent collapse.

Fig. 18: Building adjacent to a collapsed structure in the Valle Centro neighborhood being propped by steel shoring posts (SOM).

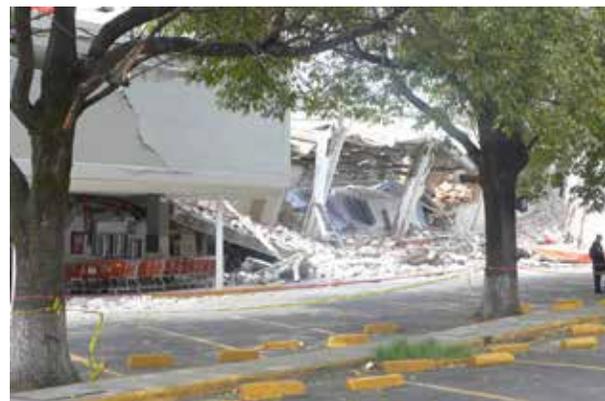
A partially collapsed department store was observed in the Coyoacán neighborhood. Both substantial racking damage and a partial collapse were observed in different parts of the store structure. Residual drift of an overhang at an entrance to the store resulted in the racking of the relatively small gravity columns providing support. A shear crack in the masonry wall above the overhang suggested that the overhang structure was supporting lateral forces, whether intended or not. Though the small ground-level columns did not appear to be adequate to prevent residual drift of the overhang, their limited lateral capacity may have prevented further collapse.

The remainder of the department store structure appeared to be an unconfined masonry wall, providing both gravity and lateral support. With the exception of a partially collapsed portion where mattresses and other heavy merchandise had been stored, the structure appeared relatively undamaged. A partially damaged panel immediately adjacent to the collapsed portion showed diagonal shear cracking, suggesting that the wall panels may have failed first due to lateral demands, then subsequently collapsed under gravity demands with the loss of structural integrity. It is also possible that the above-average mass in the collapsed portion, related to the heavy storage, may have played a role in the partial collapse.

Fig. 19: Partially collapsed department store in Coyoacán with residual racking of small ground level gravity columns (SOM).
